CALIFORNIA DIVISION OF MINES AND GEOLOGY

FAULT EVALUATION REPORT FER-108

SUPPLEMENT NO. 1

Calaveras fault (Dublin segment).

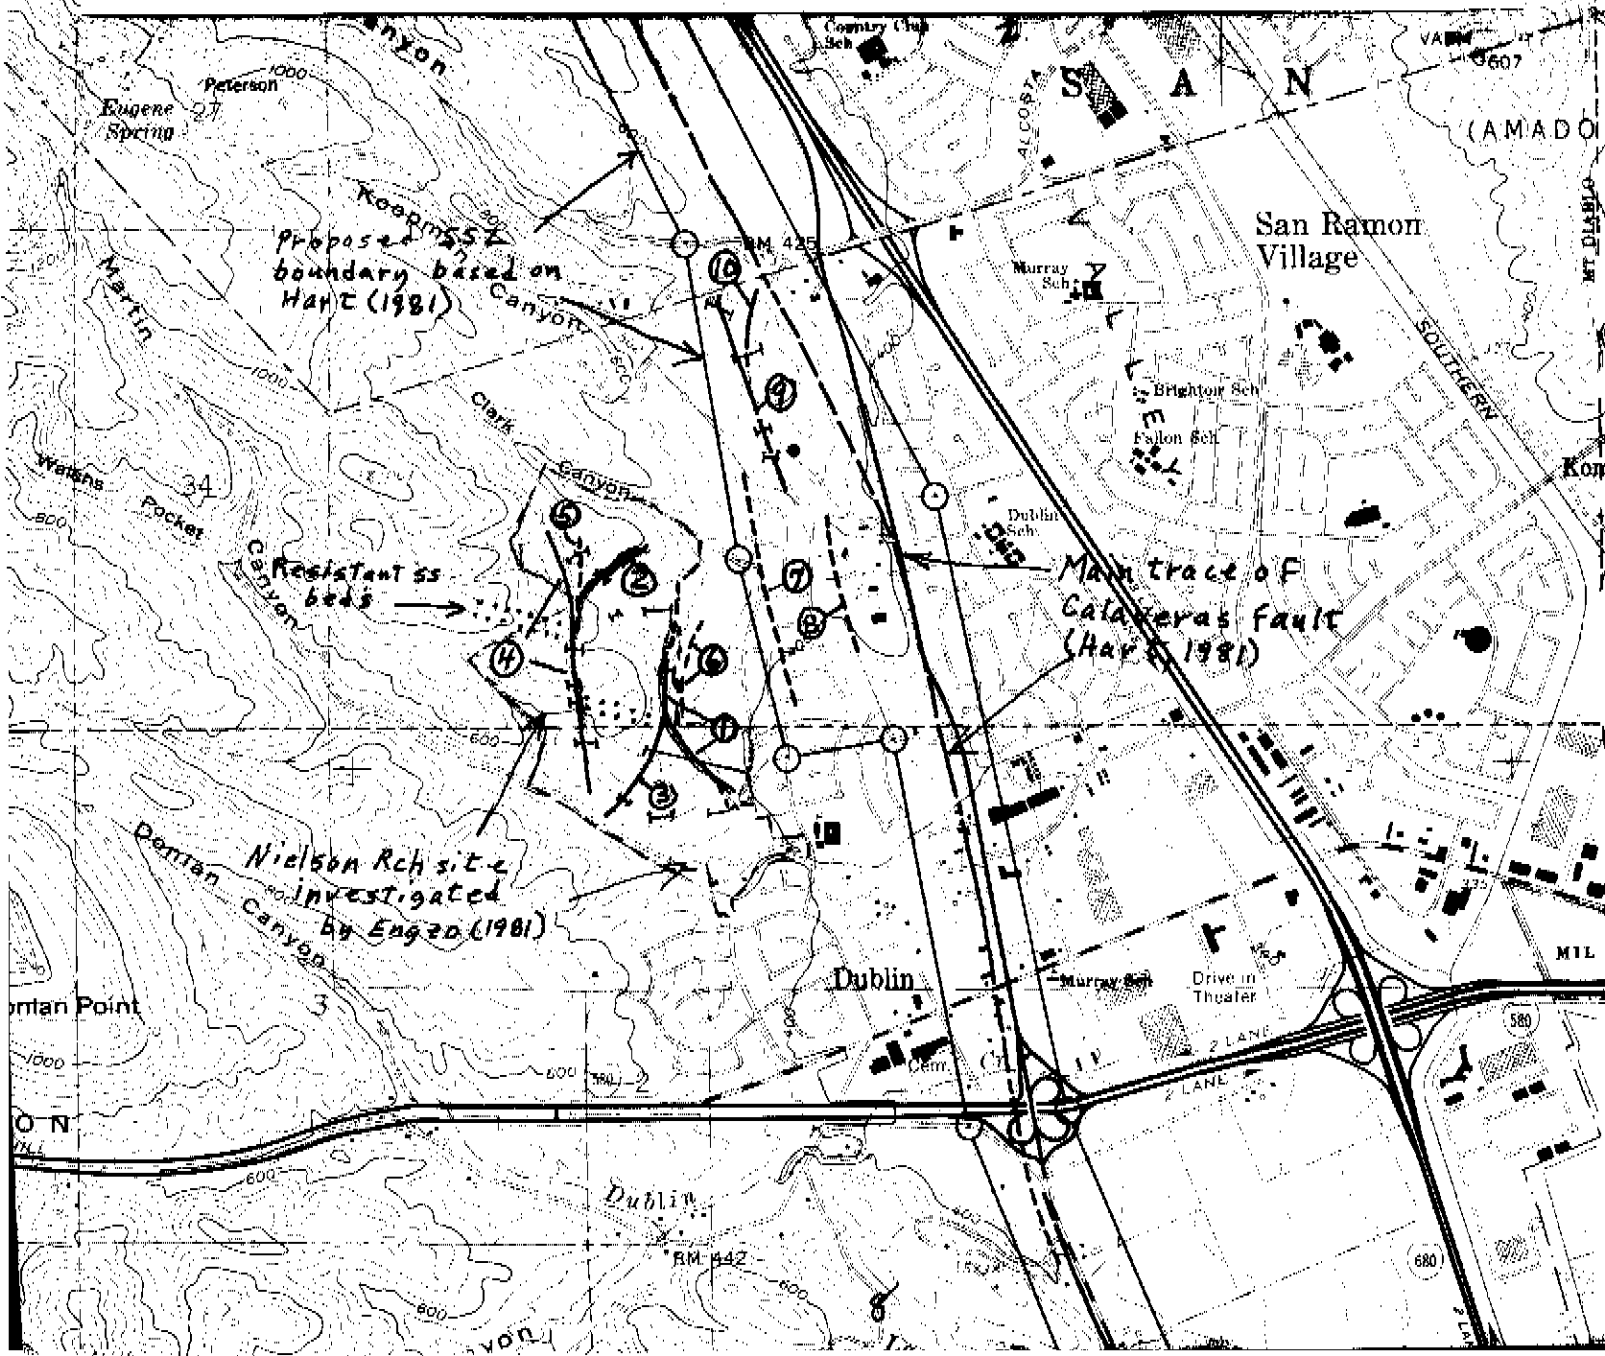
Figure 1 (Supp. No. 1, FER-108). Possible active faults on and near Nielson Ranch, Dublin. Base map from Special Studies Zones Map of 7/1/81, Dublin quadrangle.

Engeo, Inc. mapped several faults within the Nielson Ranch, mainly using aerial photographic interpretation, field reconnaissance, and trenching. The traces of the principal faults identified and the trench locations are plotted on Figure 1. The numbered traces shown on Figure 1 correspond to Engeo's numbered faults. Fault 1 and 2 are considered by Engeo to be active (i. e. Holocene) faults and sufficiently well-defined to warrant the establishment of building setback zones. Evidence that Holocene movement has occurred along these faults is based on "the consistent geomorphic spring alignment" and "observed soil offsets in trenches." The faults are considered by Engeo to be due to secondary stresses associated with the Calaveras fault (located almost a mile to the east; see Fig. 1). The sense, geometry, and magnitude of recent faulting are not stated, although trench data suggest that recent soil is offset 0.5 - 1.0 feet in three of the six trenches that cross Faults 1 and 2. Faults 3 and 4 were not considered by Engeo to be active or well-defined and setback zones were not recommended. However, their trench logs indicate that recent soils are offset ("stepped") and that soil-filled fissures occur in bedrock along both faults. Again no conclusion regarding the sense, geometry, and magnitude of faulting is provided. Although Engeo states that there is "no connection" between Faults 2 and 4, aerial photographs indicate that the former appears to be truncated by the latter (see section 6). If so, it is difficult to understand how Fault 2 can be active and not Fault 4.

Trace 1 appears on all photos as a well-defined groundwater barrier, which largely coincides with a subtle, east-facing scarp. Although minor, steeply dipping faults and shears were exposed in several of Engeo's trenches, there is little evidence presented in the trench logs of Engeo to demonstrate that the groundwater barrier is controlled by faulting. Indeed the gently dipping, clayey

siltstone beds in 3 trenches may partly cause the water barrier. The arcuate pattern of this feature is strongly suggestive of a landslide scarp. Downhill movement also is indicated by extensional features in the northerly trench. Other discontinuous groundwater barriers, associated with subtle east-facing scarps, occur to the east (partly mapped as trace 6 on Fig. 1). These features were not trenched.

Trace 2 is a short northeast-trending groundwater barrier that appears to dip gently to the northwest. The single trench that crossed this feature exposed a 35-foot wide zone of minor, steeply dipping faults in sandstone, clayey colluvium, and soils. However, because water emerged upslope from the fault zone identified on Engeo's trench log, the water barrier cannot be due to Engeo's fault 2. The presence of clay-filled joints and fissures throughout the trench suggest complex downhill movements which may have caused the minor soil offsets. This features dies out to the east and appears to be truncated by trace 5, which is mapped herein as an extension of trace 4.

Trace 4 is a fairly well-defined fault zone that truncates steeply dipping Miocene strata. Resistent, fossiliferous, sandstone beds appear to be offset right-laterally about 700-800 feet by the fault (Figure 1). The northern end of the fault, as mapped by Engeo, cannot be verified on the aerial photos by this writer. However, trace 5, a faint tonal lineament, appears to be a northern continuation of trace 4. ~~Engeo's~~ Engeo's trench T 19 exposed steeply dipping beds, shears, and soil-filled fissures which suggest this may be so. Where trenched to the south,

fault 4 is a steeply dipping, north-trending zone of bedrock faults. The nearly vertical zone of steeply dipping faults, with slices of contrasting rock types, is strongly suggestive of a strike-slip fault. Horizontal slickensides were identified on one of these faults (trench T 18C). The top soil unit is shown by Engco to be locally offset or to penetrate downward as inverted cones and fissures in bedrock. Fault 4 appear to be a significant bedrock fault, but there is no geomorphic evidence that it has been active during Holocene time and the fault cannot be traced to the north or south of the Nielson Ranch. The minor soil-offsets and the soil-filled fissures in bedrocks may be due to complex downhill movements.

Trace 7 is a fairly sharp, discontinuous tonal contrast in soil^{and alluvium}, observable only on USDA (1950) photos and ^{was} previously mapped by Hart (1981). Although one drainage across it appears to be offset right-laterally, the feature may not be due to recent faulting as it cannot be traced to the north or south. This tonal feature may be a bedrock feature (bedding or old fault) at a shallow depth or it may be artificial.

Trace 8 is a weak tonal feature at the break in slope between a bedrock hill and young alluvium. There is no strong evidence that it represents a recent fault, although the hill to the east may be a former (pre-Holocene) shutter ridge. Traces 8 and 9 are now completely covered with houses.

Trace 9 is a fairly straight drainage in a broad valley that apparently is structurally controlled. Previous workers have mapped this as the main trace of the Calaveras fault because rock units on opposite sides are of contrasting lithology and are structurally truncated (Dibblee, 1980a; Wagner, 1978; Hall, 1958). At least three trenches (possibly four) cross the feature and in no case was the presence of a recently active fault reported in soil and alluvial deposits (Hart, 1981).

Trace 10 is a short tonal line coincident with a west-facing scarp and a linear bench. It is observable on all photos examined and was also mapped by Herd (1978). A trench (report AP 1127 in Hart, 1981) across its southern end did not reveal evidence of a fault, although the soil had a small "step" (down to the west) suggestive of minor landsliding.

Based on the work of Engeo (1981) and interpretation of aerial photographs and trench observations of this writer, it is concluded that none of the faults in the Nielson Ranch area (Figure 1) clearly meet the criteria for zoning under the Alquist-Priolo Act. Only fault 4 is a well-defined fault, although traces 1 and 2 represent well-defined features that may or may-not be due to faulting. Evidence of minor, recent displacements of the soil are associated with the bedrock faults and shears in many cases, but such evidence is not confined to the fault traces identified by Engeo or to the other features mapped herein. It is concluded that the minor soil offsets are distributive in the Nielson Ranch area and most likely related to complex downhill movements within the soil and bedrock units.

Regarding the traces shown within the proposed SSZ, it is concluded that traces 7 and 8 (Figure 1) are not clearly the results of faulting and cannot be traced to the north or south. Trace 9 lies along a broad linear valley bounded on the east by a probable former shutter ridge. Although it may approximate the trace of a former important bedrock fault, trench evidence does not indicate evidence of Holocene faulting. Trace 10 could be a Holocene fault based on its geomorphic expression (linear bench, west-facing scarp), but it cannot be traced southward as active fault.

As indicated by Hart (1981) the main active trace lies to the east of traces 1 to 10. Taken as a group, traces 1 to 10 do not represent a well-defined fault or fault zone, although they are at least partly due to pre-Holocene faulting along the Calaveras fault zone. If Holocene faulting has occurred, it must have been minor and is masked by downhill movements.

It is recommended that the faults represented by traces 1 to 9 not be zoned as they do not meet the zoning criteria of "sufficiently active and well-defined." Most of trace 10 is represented by geomorphic features indicative of minor recent faulting and is close enough to the main active trace of the Calaveras to be zoned. See Hart (1981) for additional recommendations.
